# *Home Spec Solutions*

## Property Inspection Report

123 S. Main St, Anywhere, FL 34xxx  
Inspection prepared for: Mr. John Smith  
Date of Inspection: 4/1/2015 Time: 9AM  
Age of Home: 2000 Size: 2306  
Weather: Partly sunny 81 degrees F  
House faces north

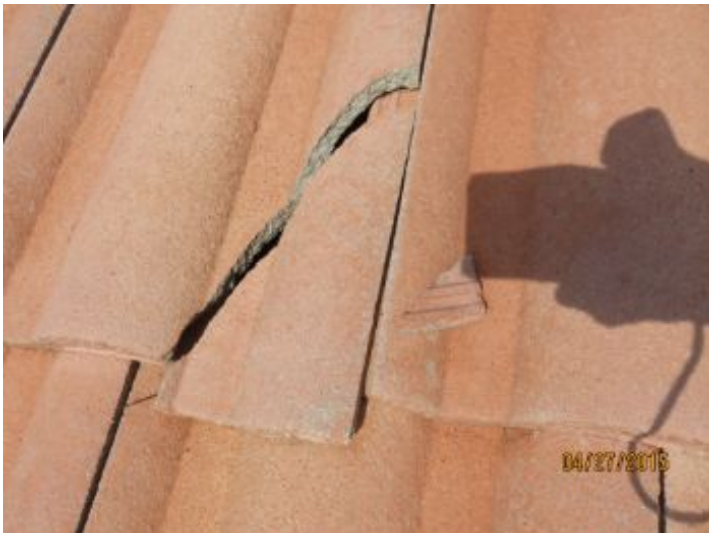
- Repair: Minor repairs to the roofing are needed. Damaged or missing roofing material should be repaired. All roof penetrations and exposed nails should be examined and sealed as necessary. Recommend licensed roofing contractor for all repairs as necessary.
- Maintenance: Access to the roof was limited due to height of roof. Second story roof was viewed from ground only. The roof is approximately 15-16 years old. The typical life of a tile roof in south Florida is 20-30 years. Recommend annual inspections of the roof by a licensed roofing contractor and regular maintenance to prolong the life of the roof as long as possible.

Broken tile

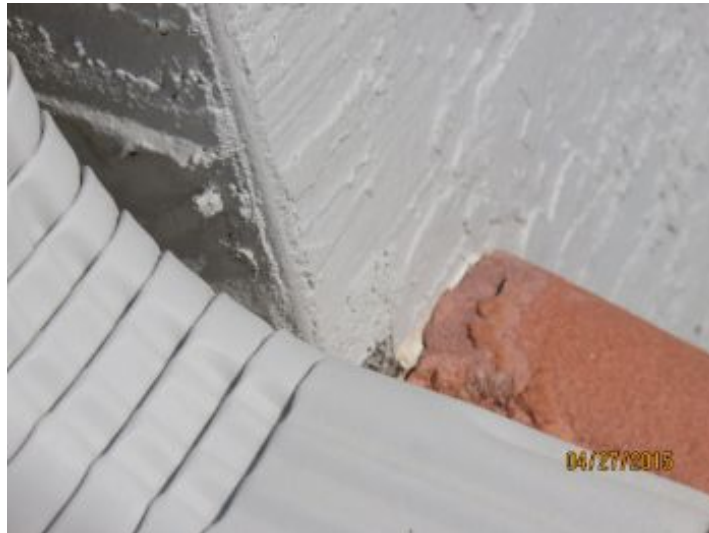
- Repair: Missing flashing should be improved where the roof meets walls of the exterior. Repair as necessary.

Missing kickout flashing

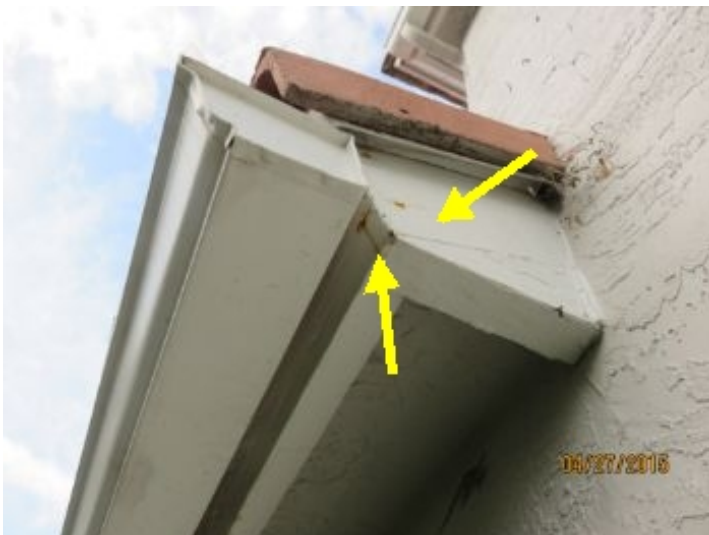
Seal areas of fascia where wood is split

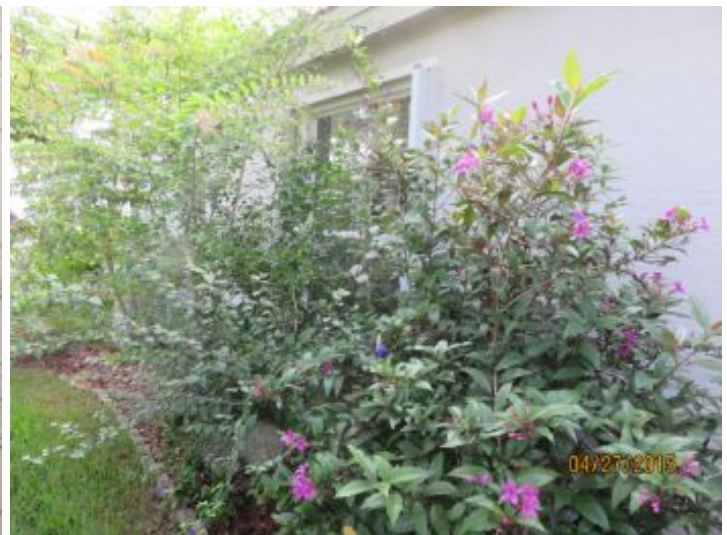
- Repair: Trees and shrubs should be cut away from exterior of house and roof.

Cut trees and shrubs from exterior and roof

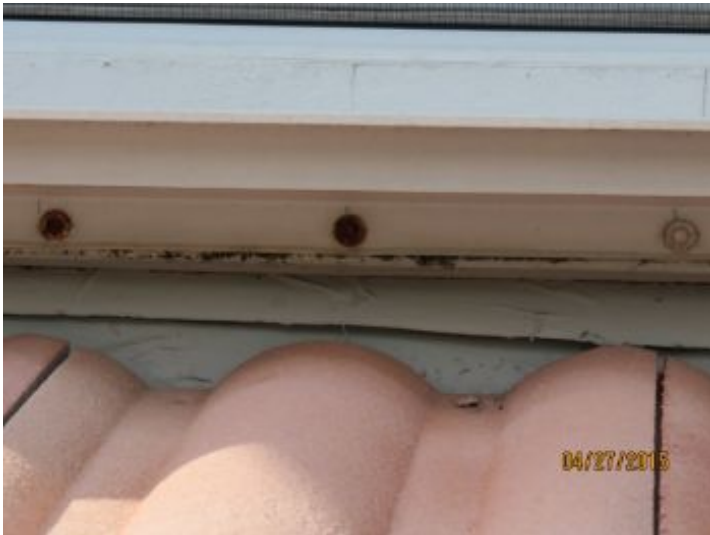
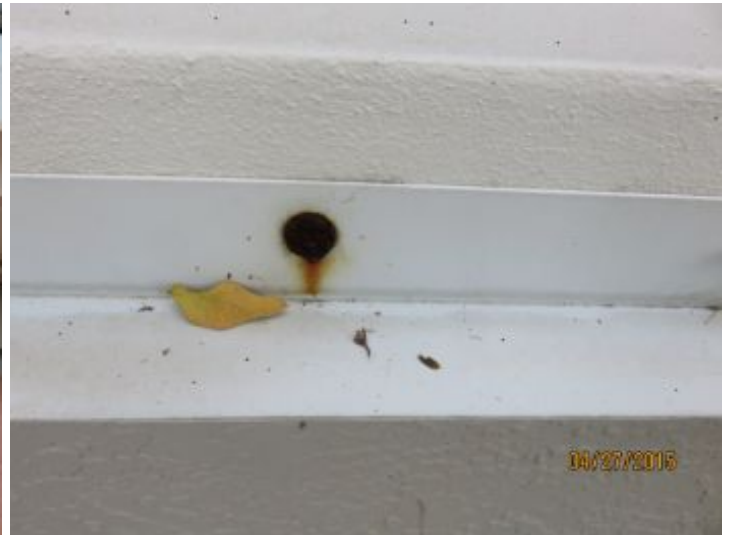
- Maintenance/Repair: All hurricane hardware and shutters should be put in place prior to emergency. It is important to make sure all hardware is available and in working order. Rusted screws should be replaced to be sure the accordion shutters perform to industry standards.
- Monitor: The south side of the exterior had very little to no overhang. It is important to monitor this area around sliders for water intrusion. No evidence of elevated levels of moisture were noted at time of inspection, but sealing and installing any missing screws will be important to help keep this areas water tight.

Rusted screws on accordion shutters

Rusted screws for accordion shutters

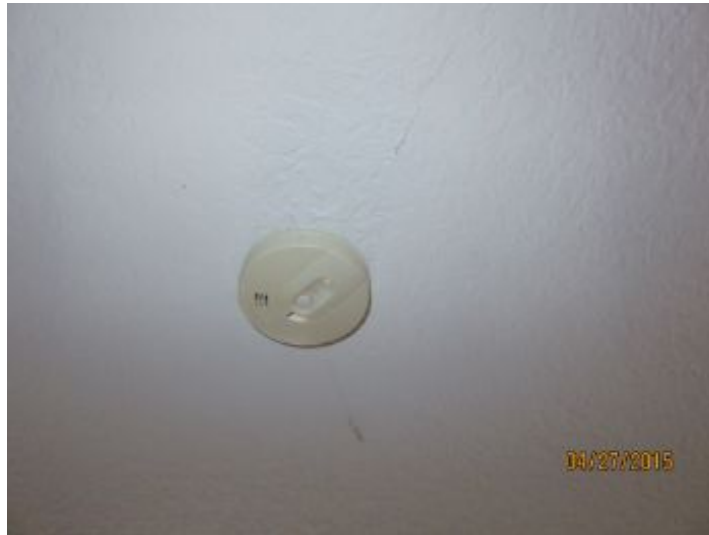
- Improve/Safety Issue: All smoke detectors should be replaced and tested prior to occupancy. A Carbon Monoxide detector should be added inside living space near sleeping areas. The typical life expectancy of smoke detectors is 10 years. These appear to be older than 10 years. Improve/Repair as necessary.

Replace old smoke detectors

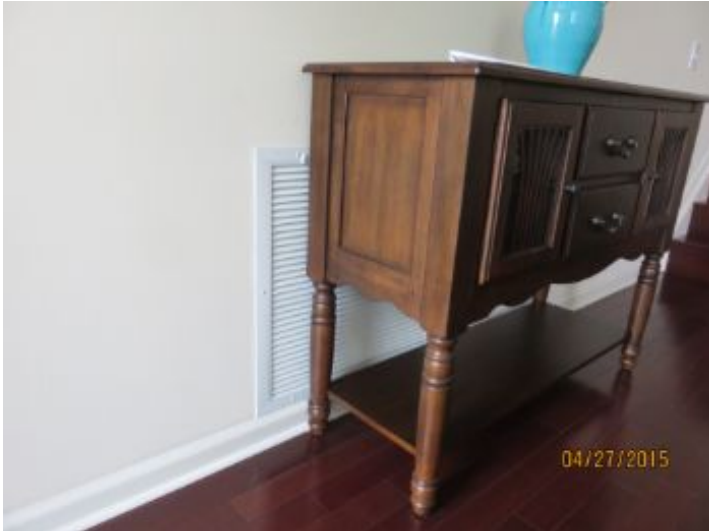
Keep furniture from blocking return

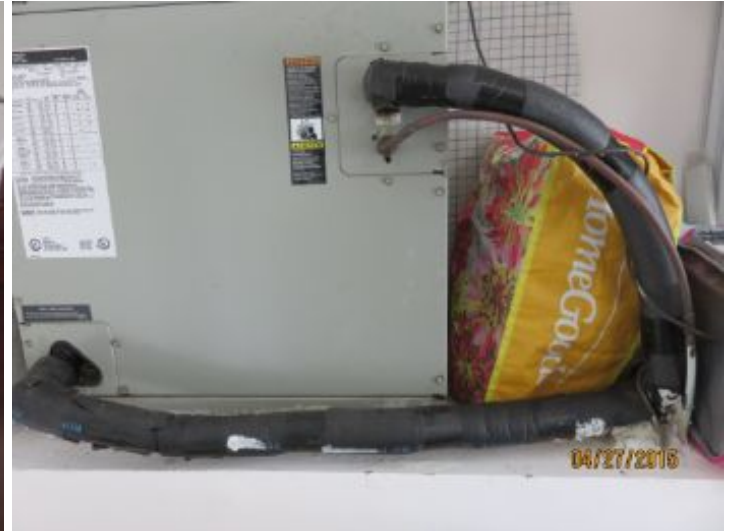
Recommend Safety/Float switch at air handler

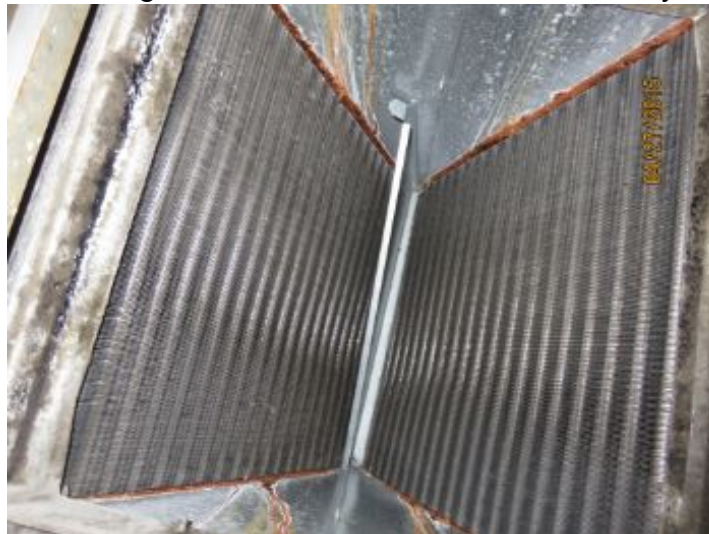
- Repair: The coils/fins should be cleaned. Organic growth was noted on the fins. Recommend licensed HVAC contractor for cleaning and regular maintenance.

View of coils at air handler

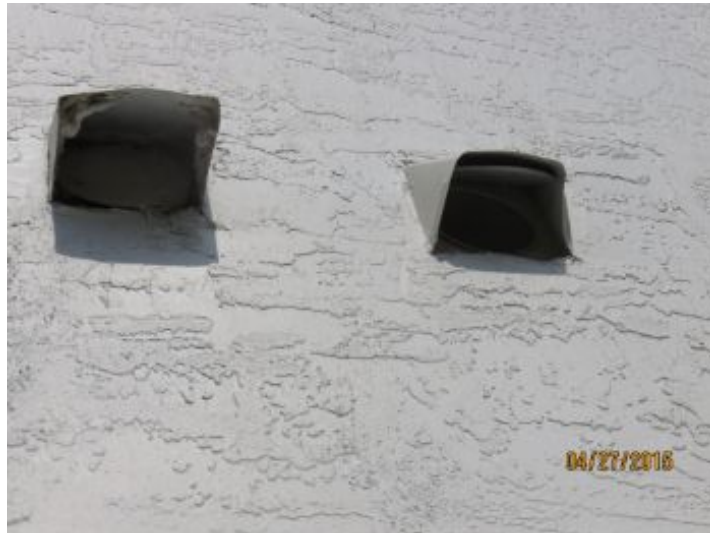
- Repair: The dryer vent should be cleaned. Also, missing covers over vents should be installed to keep unwanted animals from entering vents. Repair as necessary.

Missing screens for vent fan/dryer vent should be cleaned

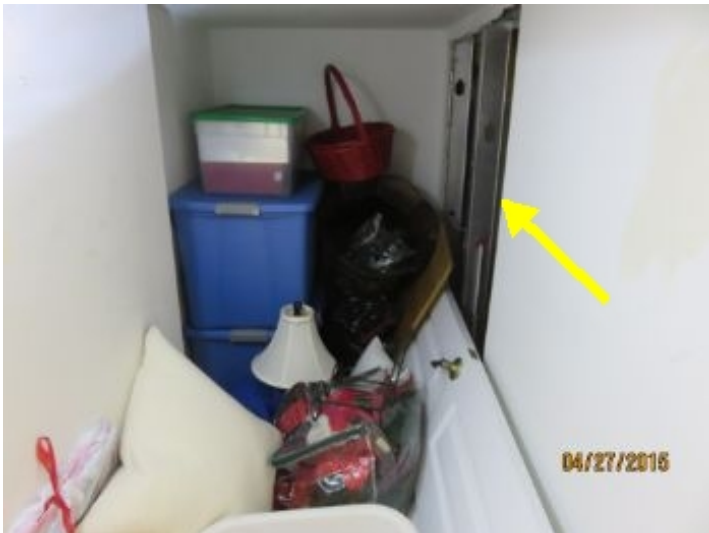
- Repair: An area of drywall is in need of repair under the stairs. Repair as necessary.

Missing drywall under stairs

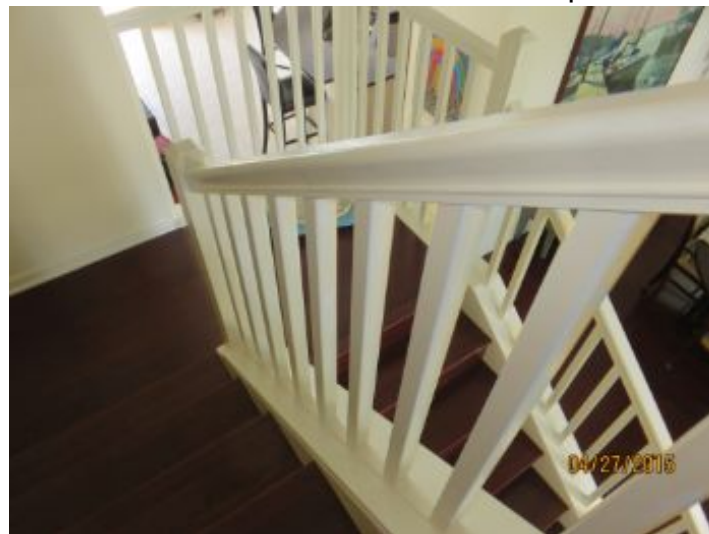
Check railings for safety on regular basis

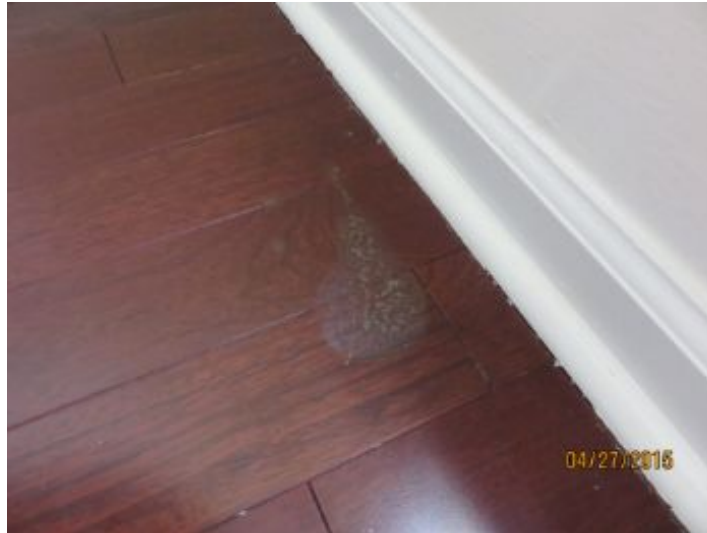
Blemish on wood floor

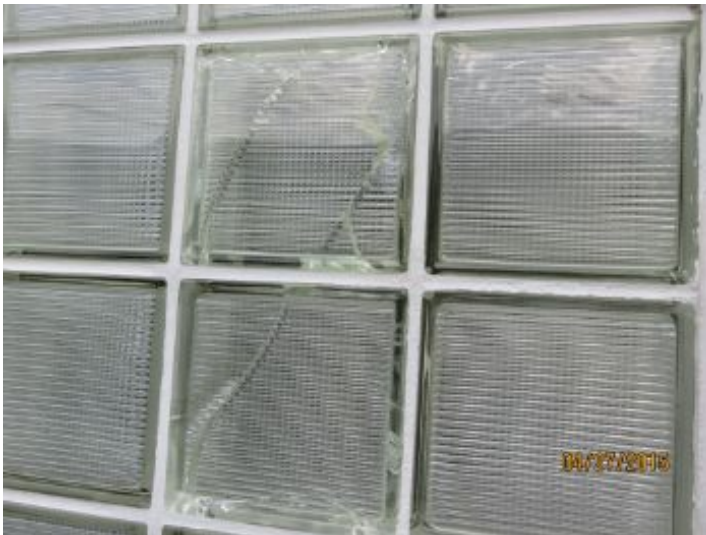
- Improve: It may be desirable to replace window screens where missing.
- Repair: Window springs need to be adjusted/replaced in order for at least two windows to work freely. Repair as necessary.
- Repair: The windows should be caulked on a regular basis to prevent water intrusion, especially upstairs windows..
- Repair/Replace: Two single hung windows and three blocks in the master bath had broken/cracked glass and were in need of repair/replacement. Recommend licensed contractor for repair/replacement as necessary.

Broken glass blocks on east side on house

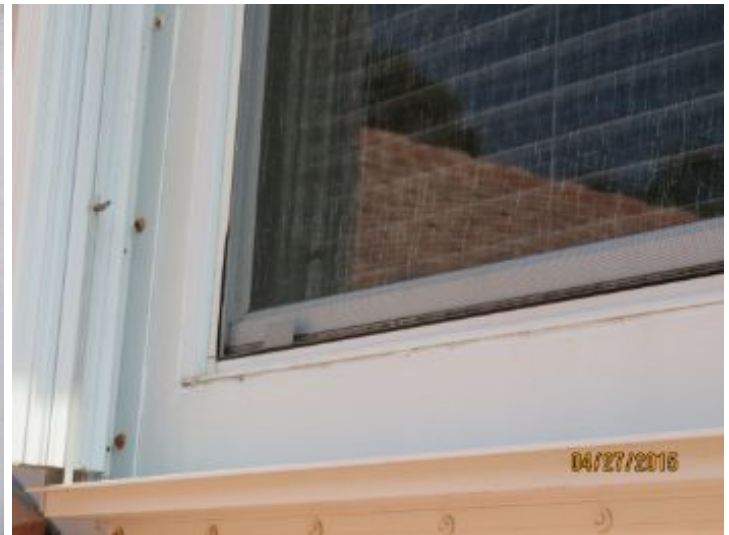
Recommend caulking around all windows

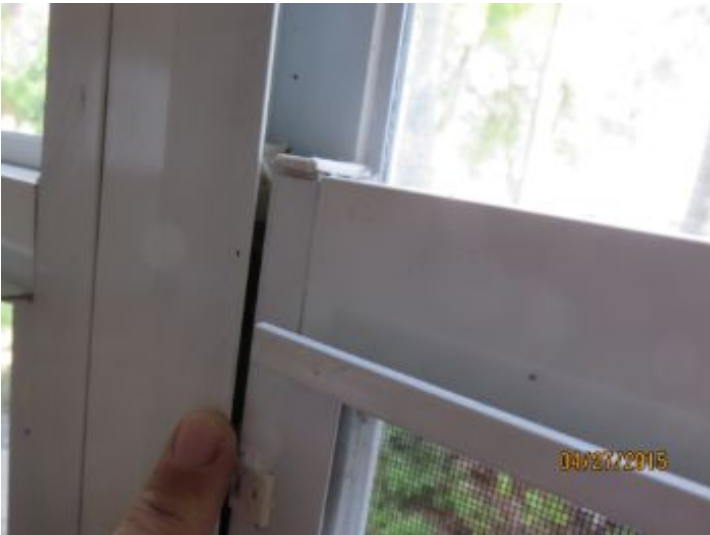
Window repair needed in living room

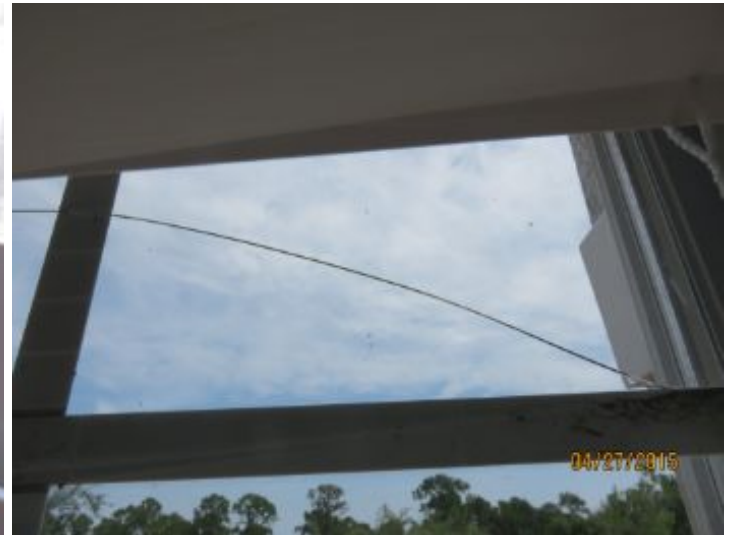
Cracked window in upstairs office

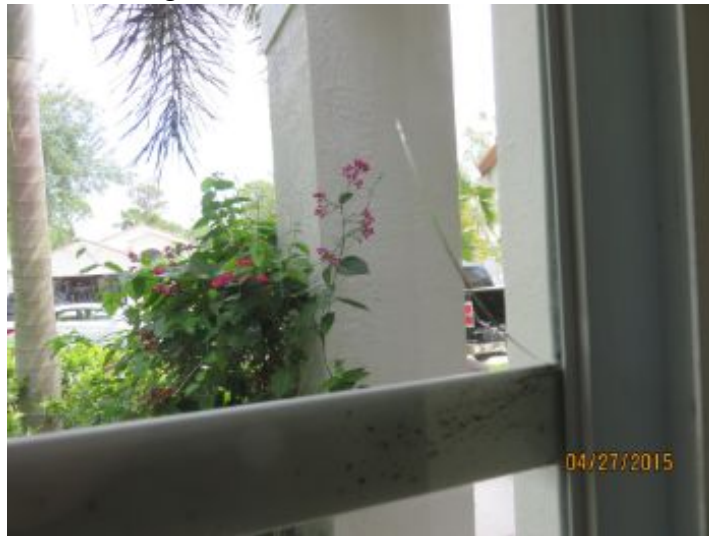
Cracked window in downstairs front room

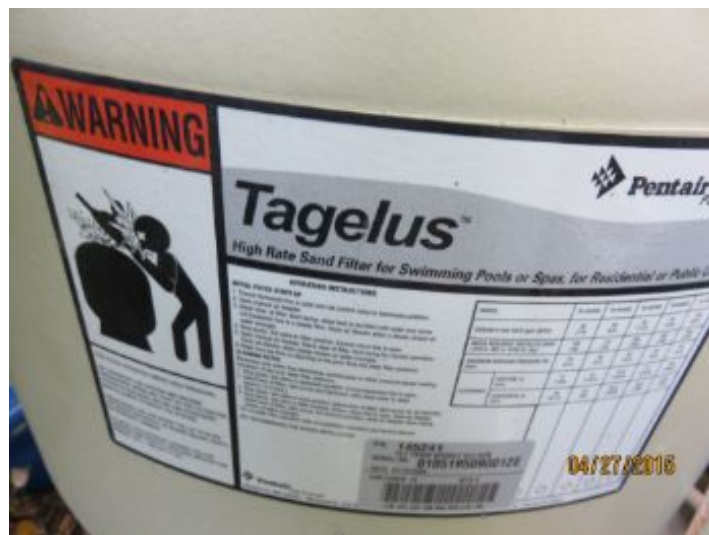
- Repair: The filter was missing the pressure gage and it should be added or replaced by a licensed pool contractor.

Sand filter

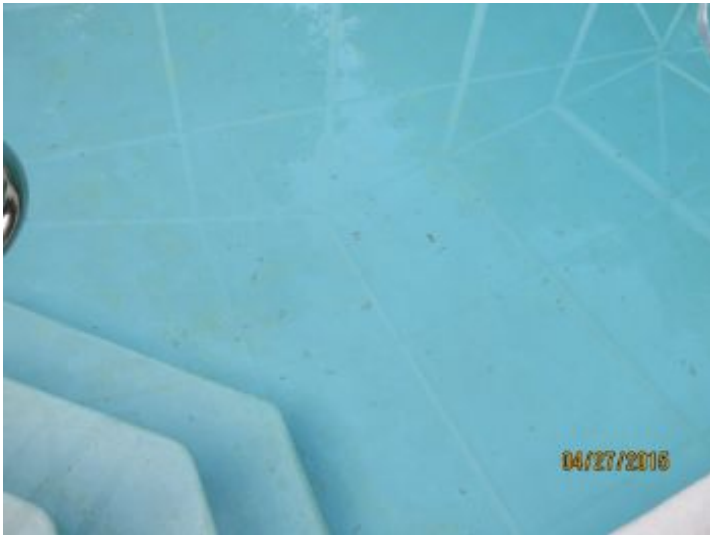
• **Repair:** Gem finish--Blemishes noted and broken tiles were noted. Grout was in need of repair and tiles should be repaired by a licensed pool contractor.

Swimming pool with blemished areas on surface

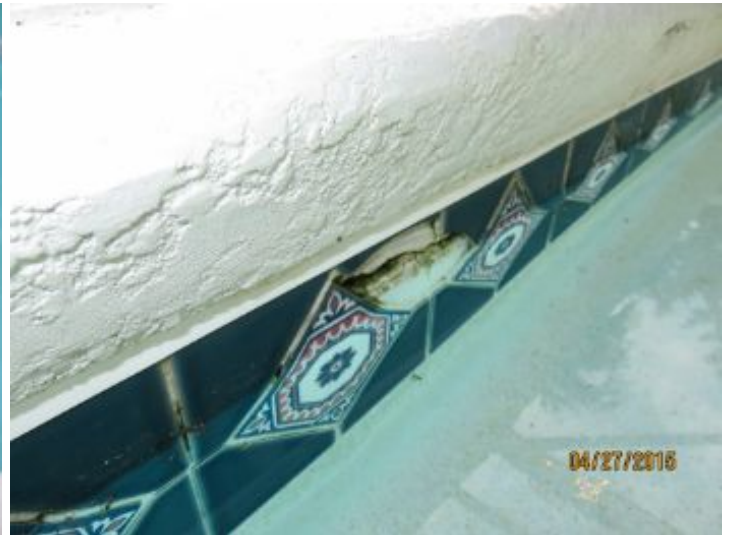
Cracked/broken tiles

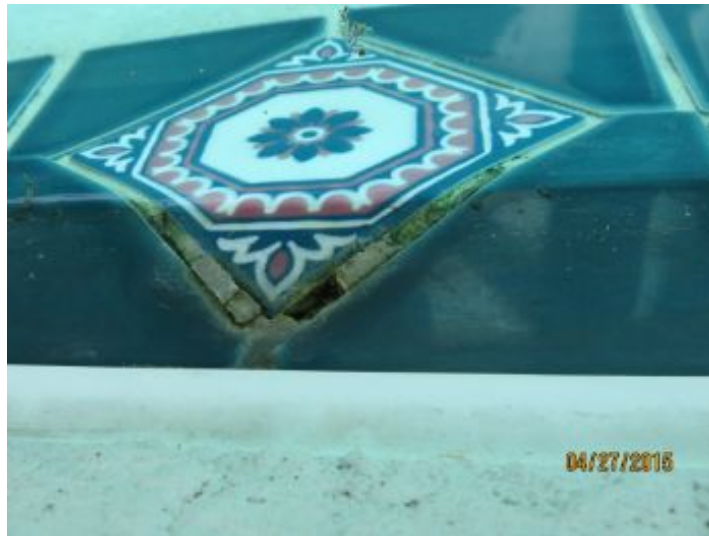
Missing grout and loose tiles
